TECHNICAL REPORT CERC-85-9

PROCEEDINGS OF THE FLOATING TIRE BREAKWATER WORKSHOP 8-9 NOVEMBER 1984

Coastal Engineering Research Center

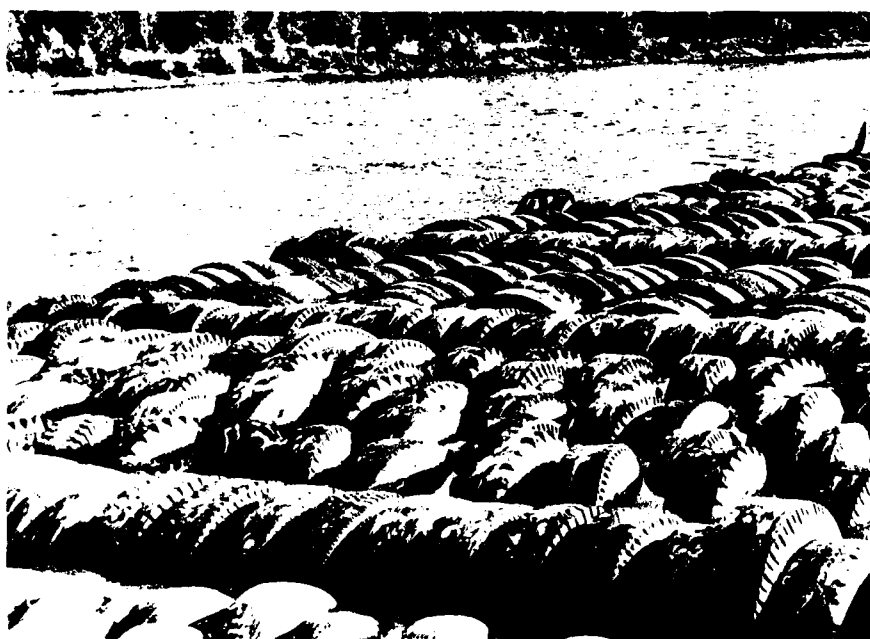
Fabricating the breakwater in sections on land and then performing the final connections on-site works quite well. Tight bundling of all sections was achieved yielding a breakwater that has retained its shape since installation. Figure 23, where the three different design configurations can be observed, attests to this claim.

Figure 23. Tight bundling achieved in all three design configurations
